College of Engineering and Applied Science
Department of Civil Engineering and Mechanics

JW Vector Connector for Precast Double-Tee Members

Report on
The Results of Laboratory Testing

September 2002

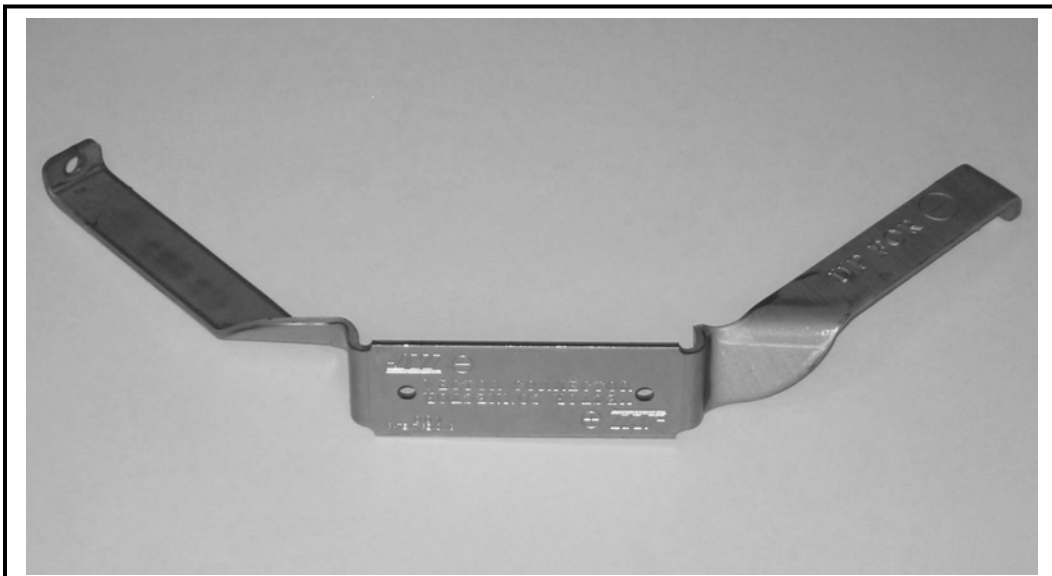
Figure 1: JVI Vector Connector

Recently, JVI implemented minor changes to the Vector Connector. JVI changed the faceplate height from 2 ½" to 2" with proportionate changes to the returns. In addition, the directions of the bent leg tips were reversed. A photograph of the revised Vector Connector can be seen in Figure 1. JVI engaged the University of Wisconsin-Milwaukee (UWM) to carry out tests similar to those conducted on the original connector. The UWM tests were carried out in August-September, 2002. The results are given in this report. For simplicity of reference, this revised connector is labeled as VC-R to distinguish it from the original Vector Connector, VC-O.

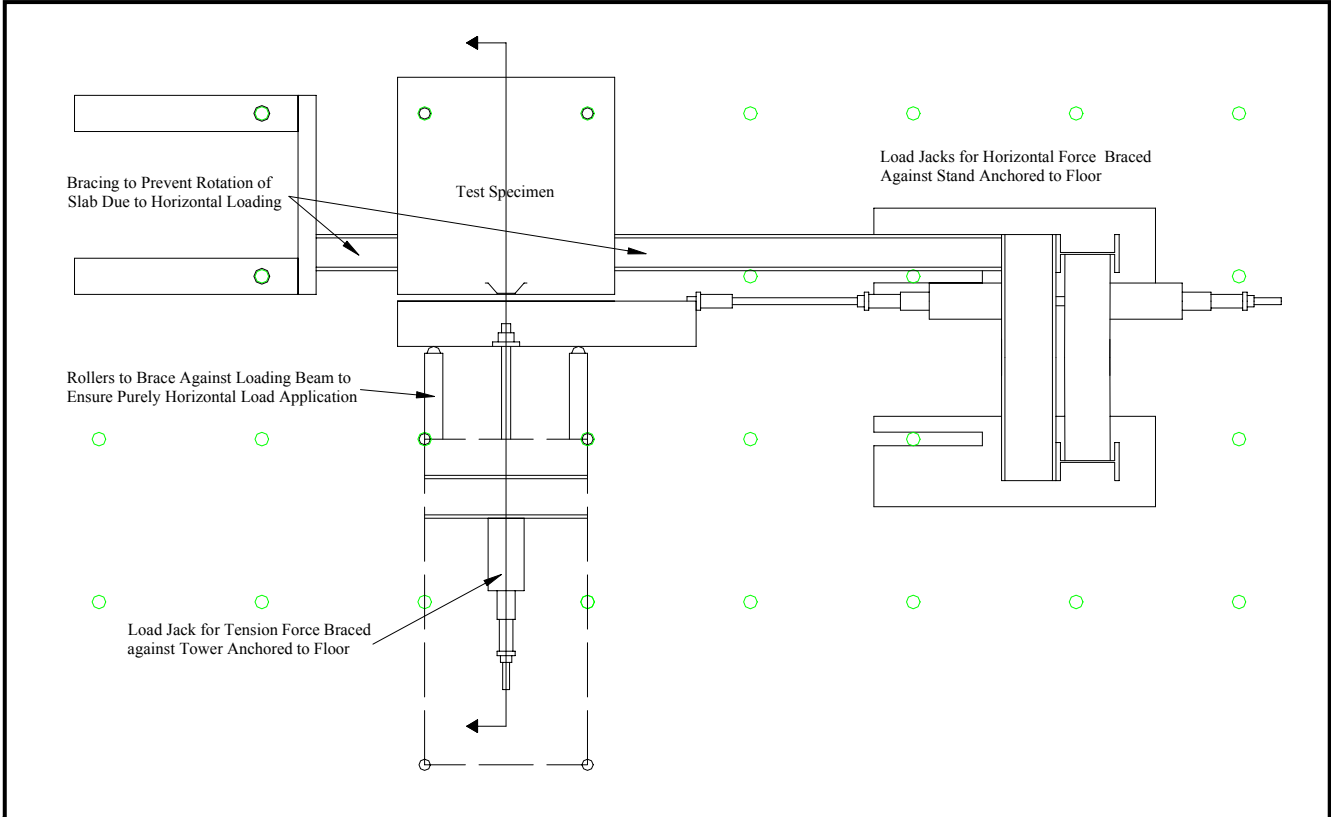
Figure 2: Plan View of Horizontal Shear Test Setup

Diagrams and photos of the test setup employed for horizontal shear tests (including those with an initial tension force applied to the connection) are given in Figures 2 through 5. Each specimen was held in place using a 3-foot spreader beam that was anchored to the strong floor of the laboratory. The slabs were also braced on each side to prevent slab rotation due to the applied horizontal loads. Each specimen had a plate welded to the connection allowing for each specimen to be bolted to a custom-fabricated tube which was used to apply the necessary forces to the connection. The loading tube rested on rollers, allowing free movement when horizontal loads were applied. Rollers were also placed against the face of the tube at each end ensuring that there was no rotation of the tube due to the applied horizontal loads.

Horizontal loads were applied to the loading tube by a rod attached to two hydraulic jacks braced against a heavy frame anchored to the floor. Horizontal forces were applied by one of the two jacks at a time to create the intended push/pull force sequence. Prior to each test the hydraulic jacks were realigned to ensure pure axial loading to the tube. A tension force was applied to the connection by a rod attached to the tube with force provided by another hydraulic jack. The jack for applying the tension force was braced against a tower anchored to the floor. The connection between the tube and the tension rod was designed to allow for the horizontal displacement that would be experienced when horizontal loads were applied. The application of the tension force was lined up to be perpendicular to the center of the connector face. Tension force was applied using a hand-operated Enerpac hydraulic pump, allowing for the desired amount of displacement to be applied to the connection.

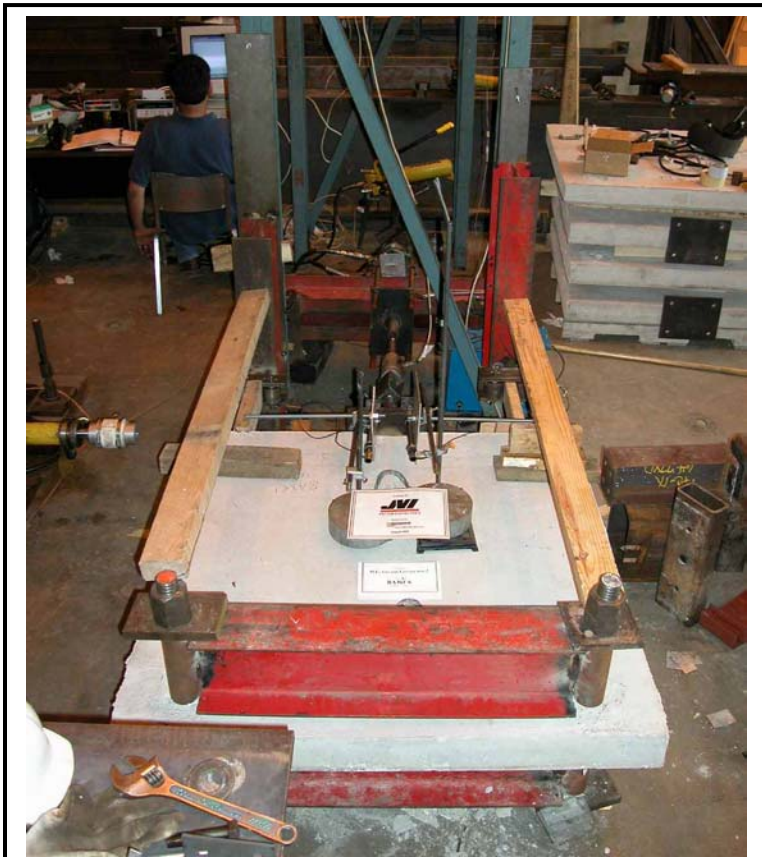
Figure 7: Tension Test Setup

A diagram and two photographs of the test setup employed for pure tension tests can be seen in Figures 6 through 8. The setup employed for these tests was very similar to the setup previously described for tension force application in the horizontal shear tests. Load was applied by a rod welded to a custom plate, which was bolted to the plate welded to the connection. Special attention was given to ensure that load was applied at the center of the connection. For pure tension tests, bracing was placed between the tower and the slab to prevent slipping of the slab due to the applied loads.

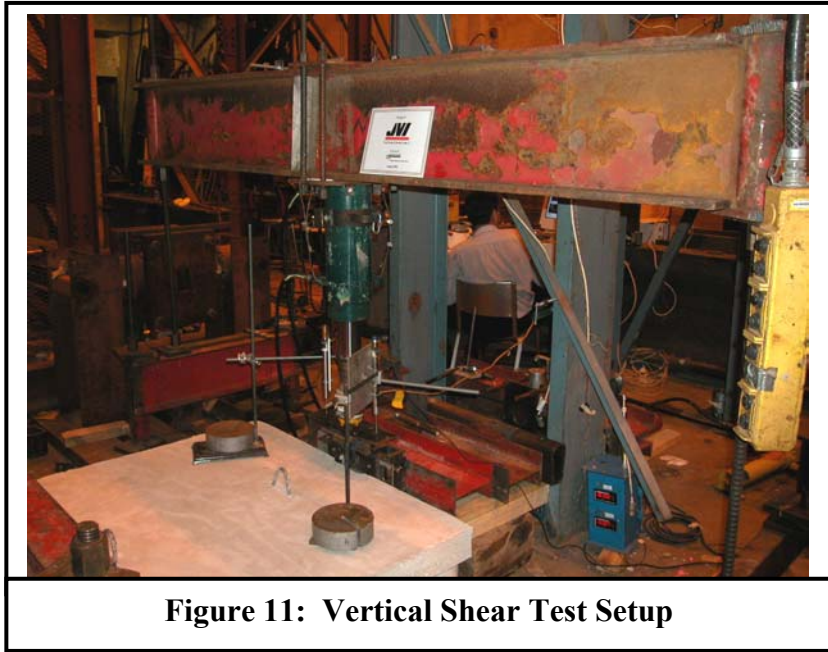
Figure 11: Vertical Shear Test Setup

Diagrams and photographs of the test setup employed for vertical shear tests can be seen in Figures 9 through 12. For vertical shear the slabs were again anchored to the floor as done in previously described tests. For vertical shear testing, supports were placed below the slab closer to the connection to prevent bending failures of the slab upon load application. For load application, a hydraulic jack was hung from a spreader beam over the connection. Special attention was given prior to each test to ensure that load was applied vertically at the center of the plate. A custom fixture was fabricated to apply the load to the plate. Rollers were also placed against the plate to prevent rotation and ensure application of a purely vertical force.

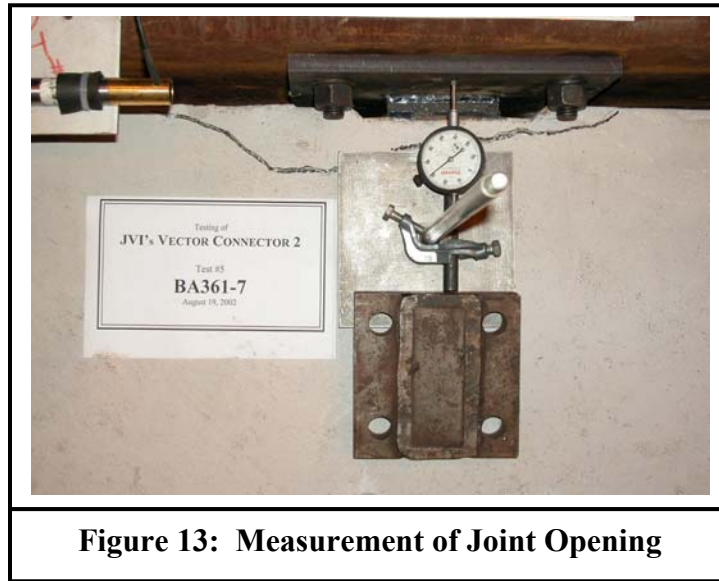
Figure 13: Measurement of Joint Opening

Horizontal loads for these tests were applied in the same manner as previously described. However, for these tests the connection was initially loaded with a tension force to cause 0.1 in. of joint opening. This displacement of 0.1 in. was read from a dial gage mounted on the slab and placed against the plate near the connection (see Figure 13). This tension load was then held while the appropriate horizontal forces were applied.

Tension loads for these tests were also applied gradually, allowing for data gathering of load as well as displacement. For tension tests also, two LVDTs, one on each side of the connection were employed. The LVDTs rested on the slab and measured the opening of the connection relative to the slab.

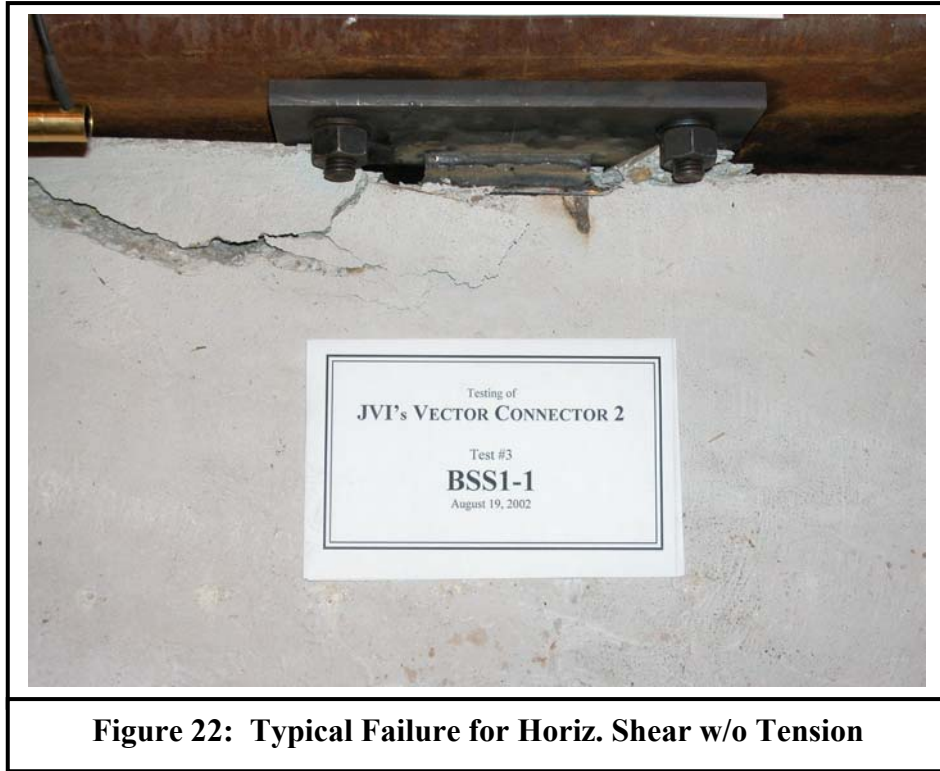
Figure 22: Typical Failure for Horiz. Shear w/o Tension

Results of this series of tests were consistent between the two types of steel. As seen, the ultimate loads are similar between the two types of steel, as is the cracking load. The load-deformation behavior of the connection, however, varied significantly with steel type. The ductility of the stainless steel connectors was almost double the A36 connectors. All specimens tested under this load type had very similar failures; cracking of the concrete at approximately 14000 lbs, with pullout of the tension leg of the connector at 19000-20000 lbs. Typical cracking for this type of test included spalling directly above the flange connector, crushing of the concrete due to the connector bearing on the side opposite of load application, and splitting of the slab at failure due to the pulling out of the tension leg of the connector. Results of this series of tests were significant because as previously mentioned; they would serve as the basis for the program employed for all cyclic testing. The following values were estimated from this series of tests:

Photos of a typical failure and a sample data graph for this type of test can be seen in Figures 21-23. Note that all data graphs, with the exception of cyclic data graphs, display two curves on the graph. These curves represent the data obtained from each of the LVDTs. Data graphs for all tests conducted in this study are included as Appendix B to this report.

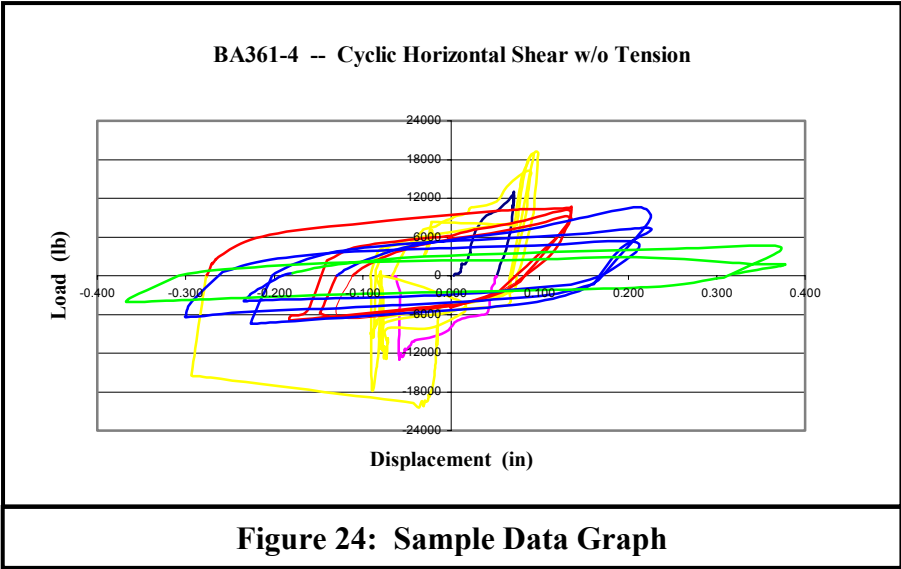
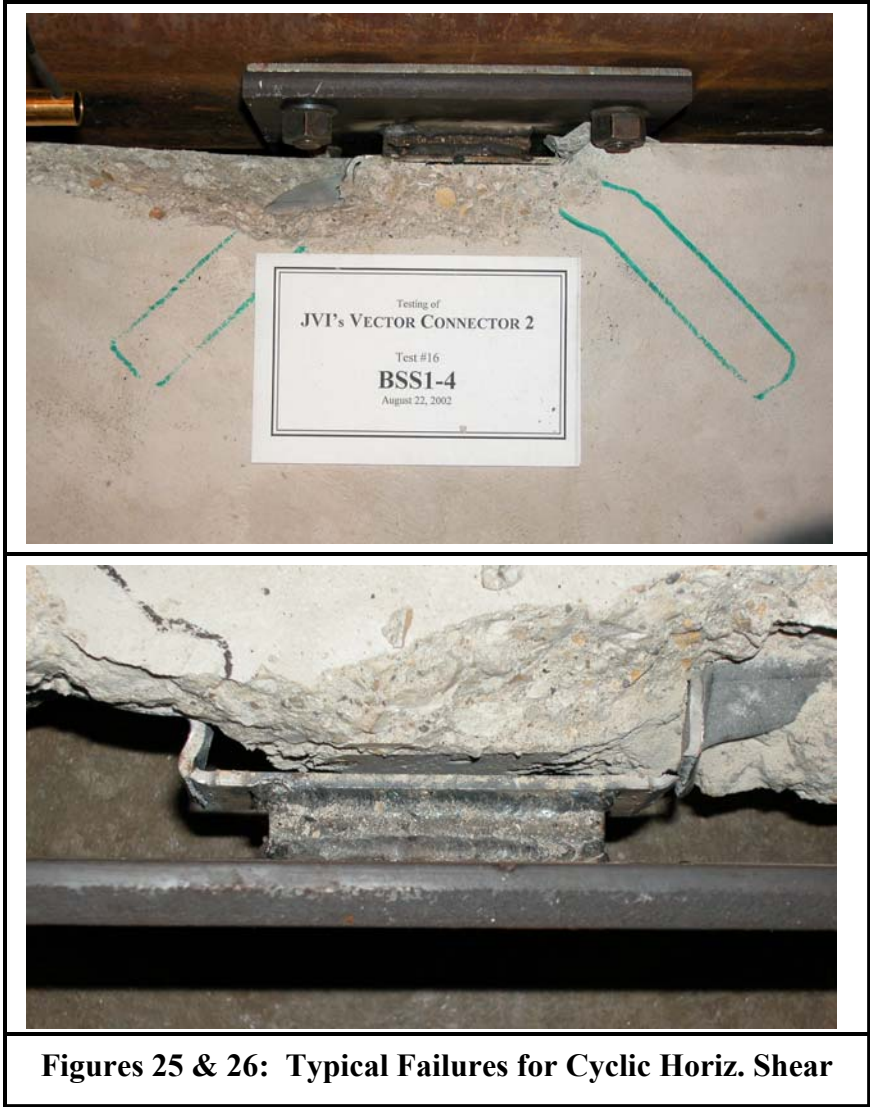
Tests for A36 connectors displayed very similar ultimate loads at approximately 21000 lbs. Ductility varied greatly between the two tests, however. Test BA361-3 failed on its first cycle up to .225" while Test BA361-4 failed on its second cycle up to a displacement of .360". In comparing test observations, Test BA361-4 experienced cracking at a much later stage, accounting for the extended life of the connection. Failure for these, as well as all other cyclic tests, was the result of faceplate rupture. Typically concrete cracking occurred during the first displacement cycle, causing the concrete surrounding the faceplate to break away. This left the connection free to displace back and forth with the cycles. As higher displacements were reached, the faceplate began to tear on both sides. This tearing occurred at the first bend in the connector between the faceplate and the leg. Typically, once tearing had initiated, the connector still functioned for at least two more cycles.

Tests for Stainless Steel exhibited ultimate loads of approximately 22500 lbs. Ductility was the same for both Tests BSS1-3 and BSS1-4 failing on the first cycle down to .525". The failure process for these tests was similar to those previously described.

Photos of a typical failure and a sample data graph for this type of test can be seen in Figures 24-26. Data graphs for all tests conducted in this study are included as Appendix B to this report.

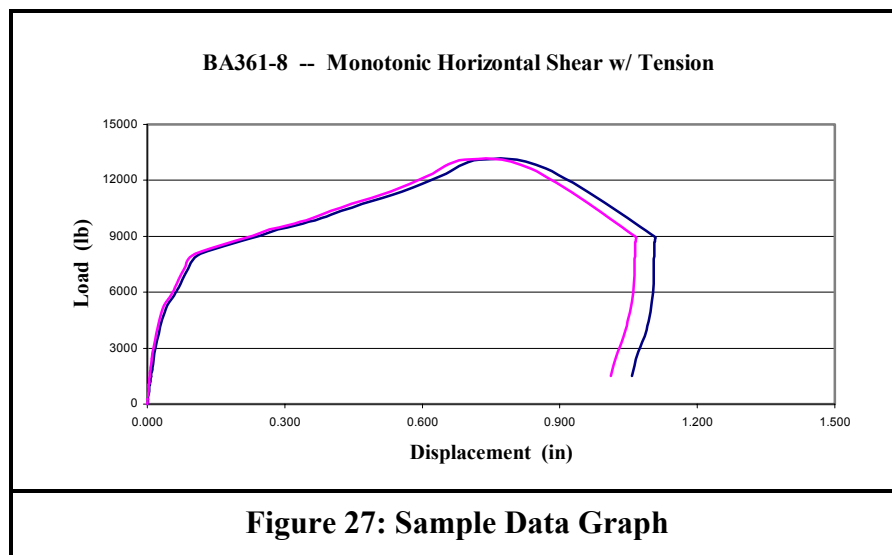
Ultimate load (13000 lbs) as well as ductility for Tests BA361-7 and BA361-8 were nearly identical. For BA361-7, the tension load was applied to cause a joint opening of .1". As this load was applied, however, further deformation occurred causing a joint opening of .15". Tension load was released and a permanent deformation of more than .1" had occurred. A load was then reapplied to the connection to place it under tension and held while horizontal testing was initiated. For BA361-8, tension load was increased to cause a joint opening of .1", this load was then held and horizontal testing was initiated.

Differences in tension load explain the varying results between Tests BSS1-7 and BSS1-8. For Test BSS1-7, as tension load was applied, joint opening increased to .12" of permanent deformation. The load was then released and horizontal testing was carried out with no tension force applied to the connection. For Test BSS1-8 tension load was applied to cause .1" of joint opening. This force was then held while horizontal testing was conducted.

A sample data graph for this type of test can be seen in Figure 27. Photos of typical failures have not been included for this series since they are identical to tests done without tension applied to the connection.

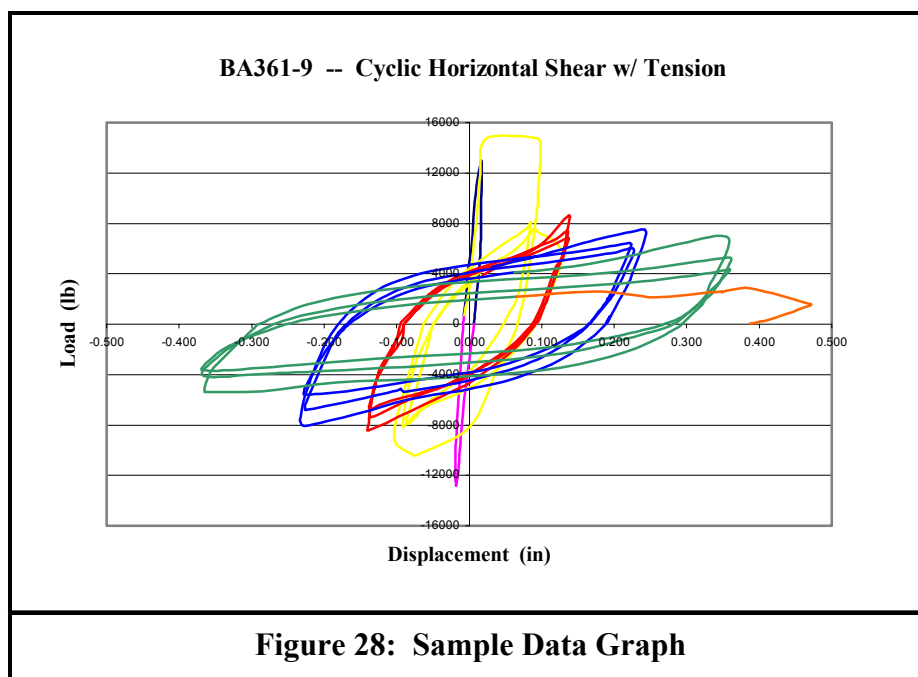
Results of this series of tests were again very consistent. For all tests in this series, a tension load was applied which resulted in 0.1” of joint opening. This load was then held while cyclic horizontal testing was conducted. Failure for these tests were identical to cyclic tests conducted with no tension force applied. Rupture at the ends of the faceplates was again the cause of failure.

A sample data graph for this type of test can be seen in Figure 28. Photos of typical failures have not been included for this series of test since they are identical to tests done without tension applied to the connection.

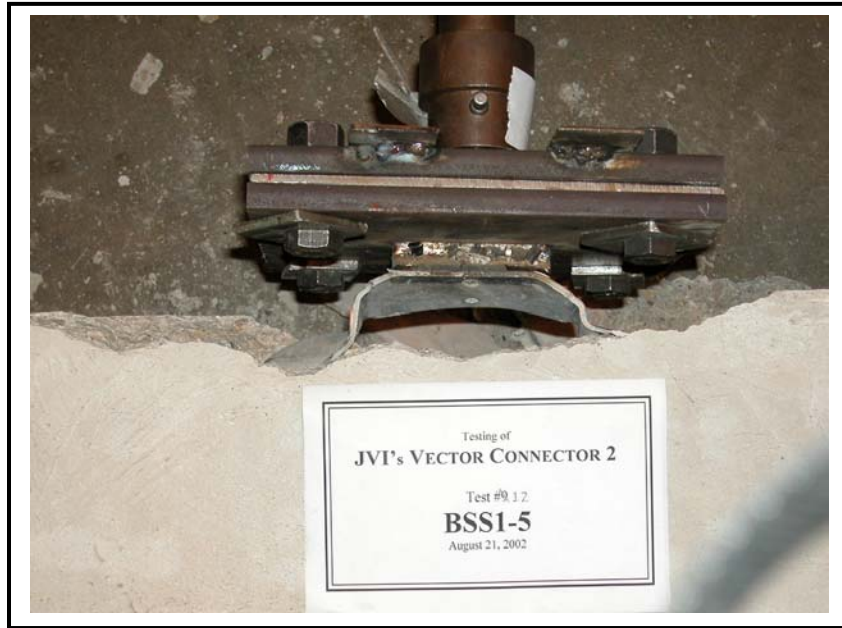
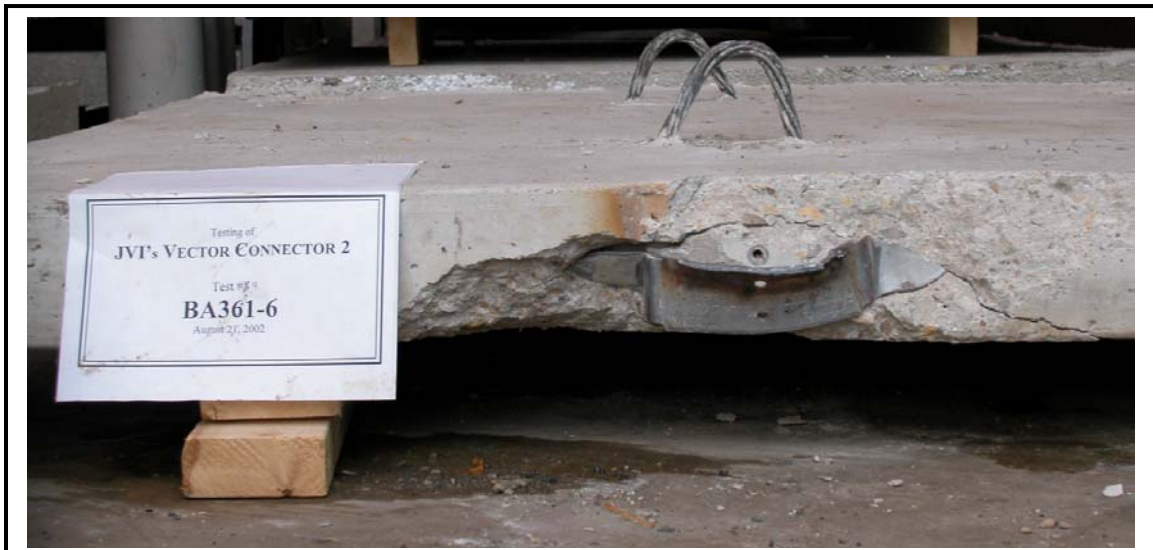
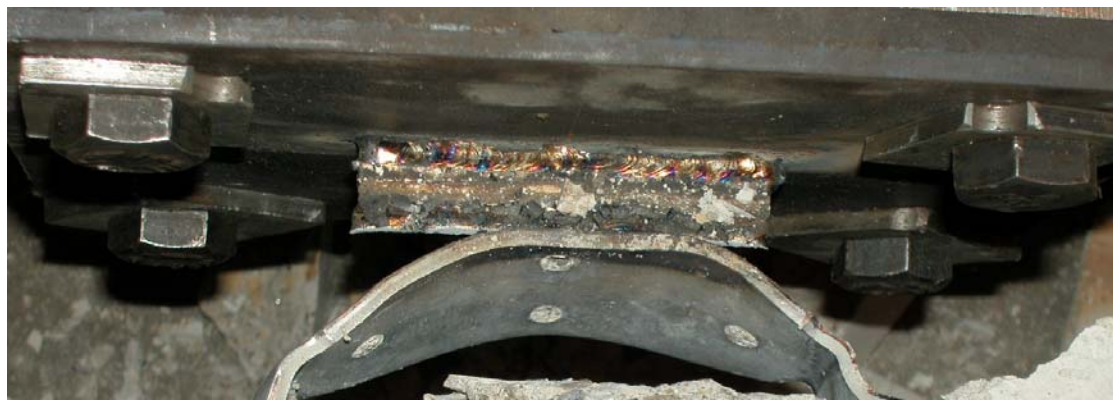
Figures 30 through 32: Typical Failure for Tension Only Test

Results for this series of tests were again consistent. As the tension load was applied to the connection, concrete around the faceplate broke off and the faceplate began to fold downward. Once the faceplate reached an approximate angle of 30° compared to its original position, the weld began to tear from each end, propagating rapidly towards the center. This was the mode of failure for all monotonic tension tests.

- (4) In the tension load only tests, the failure occurred due to rupture of the weld and thus the connector tension strength could not be achieved. Pretest visual examination of the specimens and welding did not reveal any obvious flaws or cracking in the weld zones.

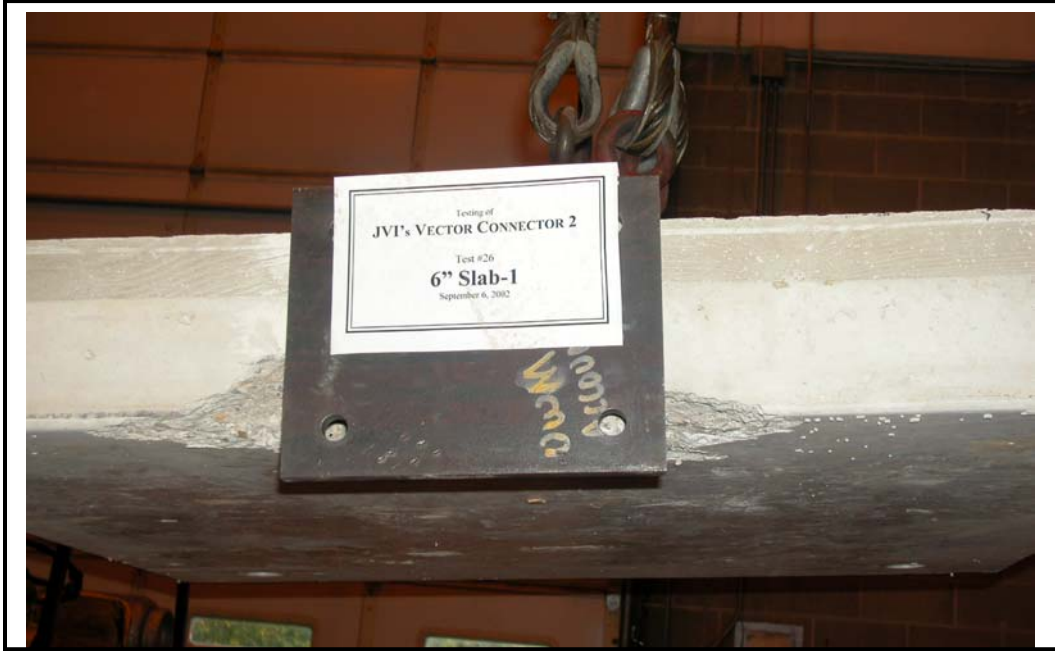
Figure 34: Front View of Slab

Vertical shear test results are remarkably consistent. All failures were due to spalling of the concrete on the bottom surface of the slab below the connector. All failures were brittle due to the failure of the concrete, thus the ultimate load was the same as the cracking load.

- (5) Spalling of concrete at the bottom of the slab occurred in all vertical shear tests. Use of auxiliary reinforcement, such as welded wire mesh has been suggested to help against such spalling.

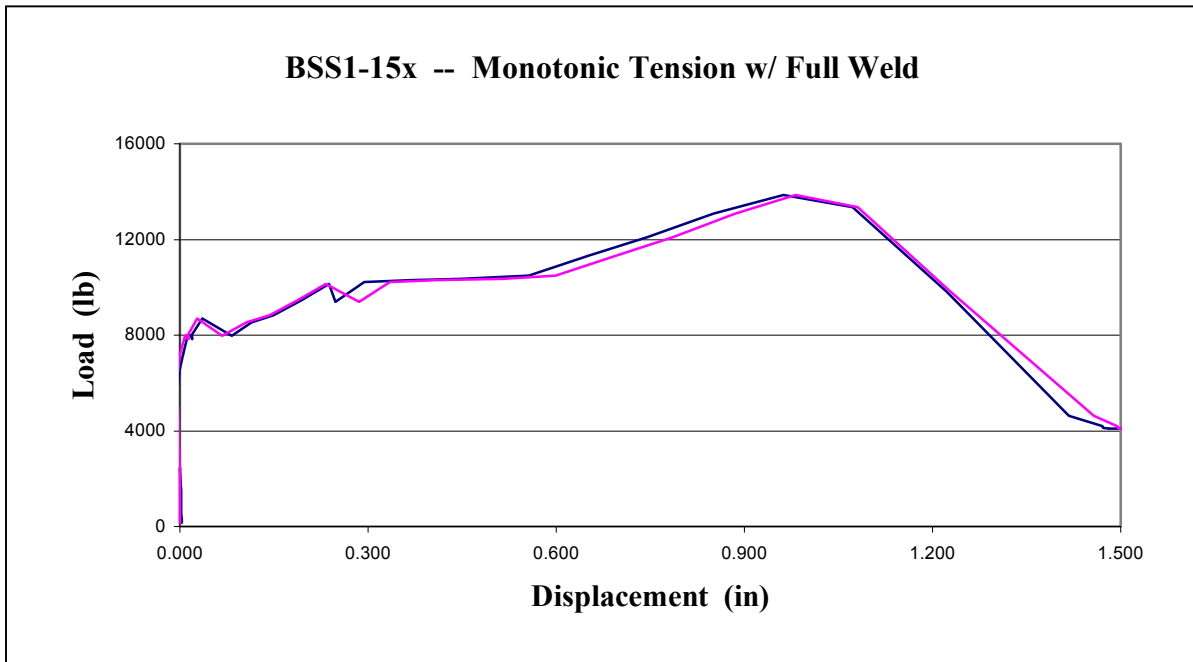
Initial cracking for Test BSS1-15x occurred at an applied load of 8700 lbs. Failure for this test was similar to those described in the body of the report, however, the connector faceplate did not fold down as seen previously. Due to the symmetry caused by welds on the top and bottom, the faceplate remained vertical throughout testing. The ultimate load for Test BSS1-15x was 13855 lbs. Failure was due to pullout of one of the connector legs. The data graph for Test BSS1-15x is shown below.
